## 6.6 PARKS

*Parks, Open Space, Trails and Recreation Master Plan*

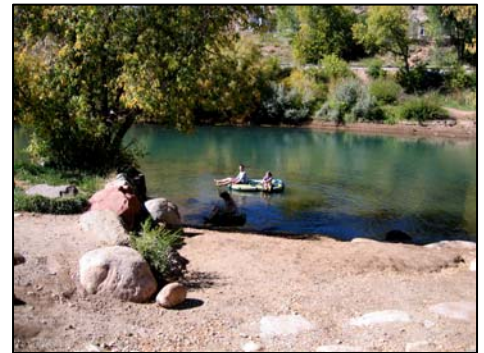
6.6.1 33RD STREET RIVER ACCESS SITE

- The site is poorly configured to manage the traffic it receives, especially on weekends and during the peak summer season
- Nearby residents are consistently concerned about the congestion, illegal roadside parking, and occasional unruliness of the crowds
- The road and road shoulder quality is significantly deteriorated as a result of poor design and insufficient space for the predominant use
- Parking is insufficient and limited to on-street
- The design and limited capacity of the site in contrast to heavy usage and demand places river user groups at odds with residents. Improved site conditions could work to improve the relationships between users, residents, and law enforcement.

- Collaborate with predominant users groups, residents, and Public Works Department to establish a master plan for this site that can address design and configuration issues that exacerbate user conflicts with residents and congestion

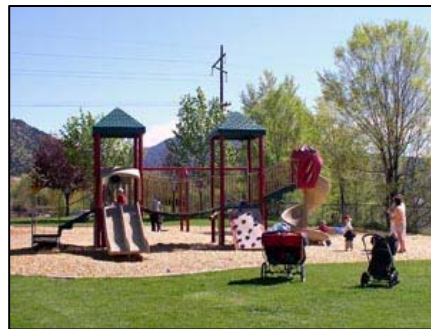
6.6.2 ANIMAS CITY PARK

- No challenges observed; the park is in excellent condition

- Shade shelter for the playground
- Improved bank protection and river access trails between the park and the Animas River

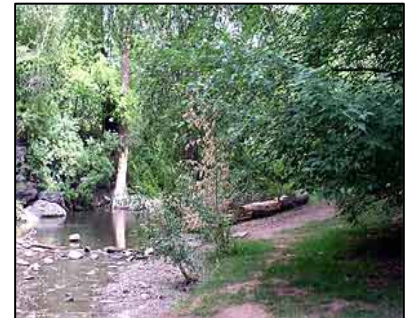
6.6.3 BROOKSIDE PARK

- No challenges observed; the park is in excellent condition

- Enhance Web site information educating the public about the chemical- free park concept and promote volunteer efforts with maintenance and manual weed removal

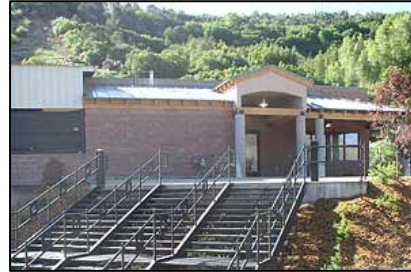
6.6.4 CHAPMAN HILL ♦

- Rope-tow ski lift is old and in questionable operating condition
- Bottom of ski hill should be re-graded to prevent problems with abrupt ski area boundary to parking area
- Entry stair to ice rink pavilion needs repair
- Parking capacity is inadequate for peak usage
- Old maintenance and storage buildings are deteriorated and need substantial repair

- Increased parking capacity
- Upgraded ski hill amenities
- Second sheet of ice to service year round use

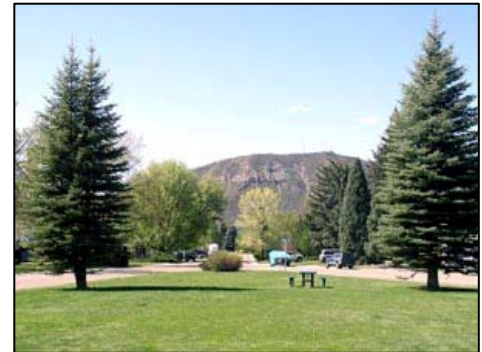
6.6.5 CRESTVIEW PARK

- Irrigation system is poor – battery-powered, stand alone system

- Upgrade irrigation system with link to central control system
- Small playground equipment

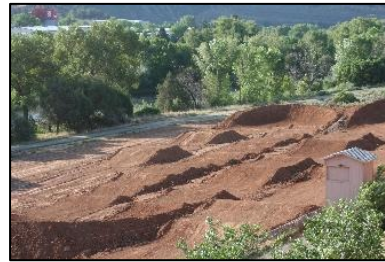
6.6.6 CUNDIFF PARK

- Park is currently used by Public Works for snow stockpiling from road clearing during winter months. This creates usage limitations on the spring shoulder season, as well as significantly damages the park’s parking area by creating rough grades, drainage problems, and litter.
- Parking capacity is not sufficient to support heavy usage of commercial river outfitters and BMX track users
- BMX track is small and has limited support amenities
- Future park redevelopment initiative may be challenging due to competing interests

- Seek alternative location for Public Works snow stockpiling either on-site or off-site
- Redevelop parking area and additional park support amenities
- Expand amenities supporting BMX track or relocate track to an alternate site

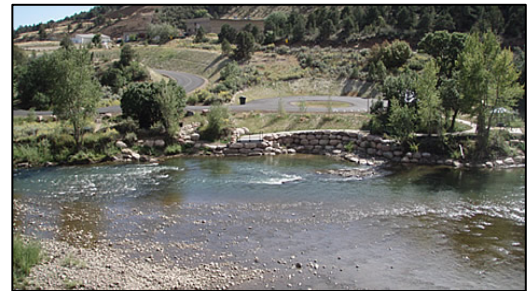
6.6.7 DALLABETTA PARK

- Littering and vandalism around restrooms is problematic

- Additional interpretive signage

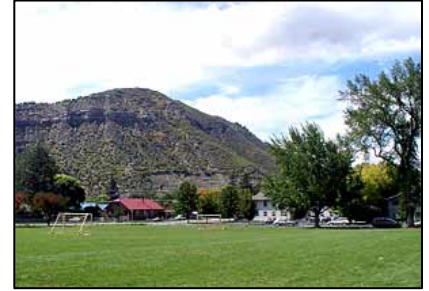
6.6.9 FANTO PARK

- Predominant use of the park is by the school and its students, but City Parks and Recreation Department is responsible for majority of maintenance

- Additional support from school for park maintenance

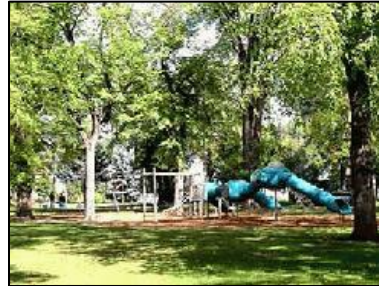
6.6.10 FASSBINDER PARK

- Irrigation system is old and deteriorated
- Irrigation system is not linked to central control system
- Park is popular for the homeless population
- Playground equipment is frequently vandalized

- Upgrade irrigation system and link to central control system
- Update play equipment

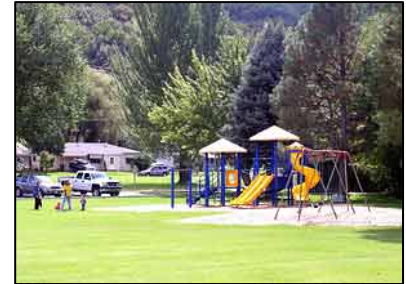
6.6.11 FOLSOM PARK

- Water for the restrooms is on the irrigation feed, therefore interrupting use during irrigation system maintenance
- Sewer line from the restroom runs uphill and sometimes creates back-ups
- Spring use is a challenge due to ground saturation and turf protection issues
- Due to limited sports fields in town, this park is over utilized

- Relocate restrooms to the center of the park

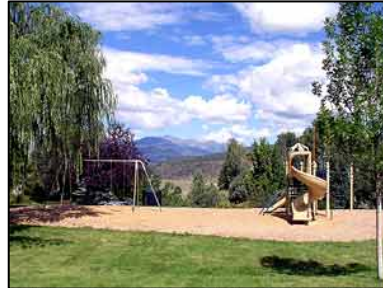
6.6.12 HILLCREST VIEW PARK

- No challenges observed; the park is in excellent condition

- Potential shade structures for play equipment

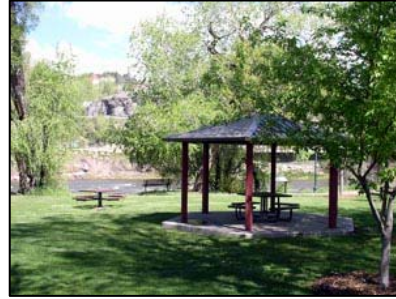
6.6.14 IRIS PARK

- No challenges observed; the park is in excellent condition

- Additional interpretive signage
