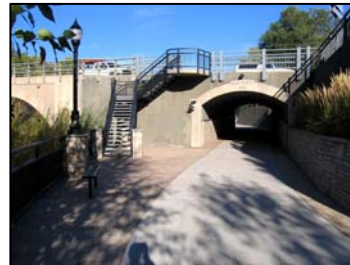
- Segments with asphalt surfaces are in need of patching and resurfacing in many areas
- Concrete surfaced segments are wider (10 feet) and more updated; asphalt surfaced segments are more narrow (eight feet) and in need of repair.

- Continue expansion of the ART both north and south of town
- Resurfacing and widening of older segments
- Additional interpretive and information signage
