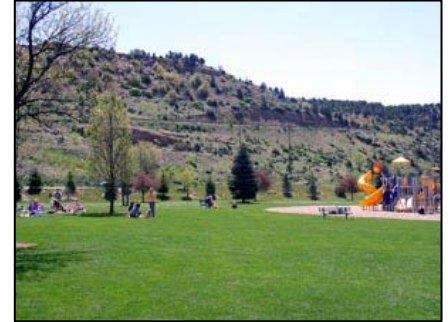
6.6.27 SANTA RITA PARK

- Playground equipment is un-shaded
- Parking capacity is marginally adequate
- High-shed originally designed to cover historic train is not being used for its intended purpose
- Sand volleyball courts feature poor site design creating drainage issues; sand is poor quality

- Shade shelters for playground.
- Upgraded sand volleyball courts
- Upgraded whitewater park amenities
- Volunteer support for maintenance

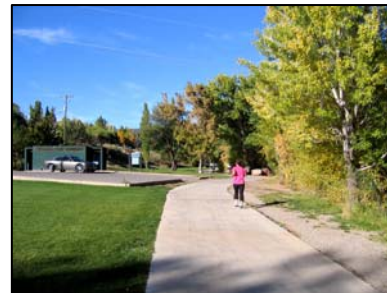
6.6.28 SCHNEIDER PARK

- Irrigation system is disconnected between upper and lower parks
- Park requires substantial maintenance effort for heavily littering and vandalism
- Park is popular for the homeless population

- Link irrigation system of upper and lower parks
- Update restrooms

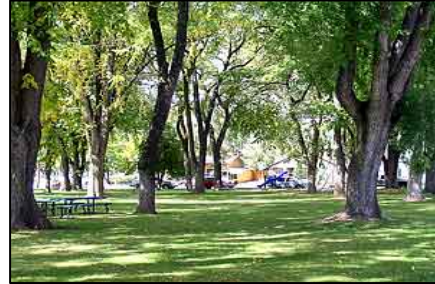
6.6.29 VILES PARK

- Irrigation system is old and deteriorated
- Irrigation system is not linked to central control system

- Upgrade irrigation system
- Additional picnic tables

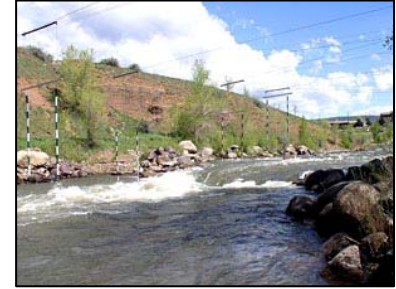
6.6.30 WHITEWATER PARK

- Parking capacity is marginally adequate
- Whitewater features require updating and stabilizing in the river
- Bleachers and spectator area can improve with limited landscaping and repair

- Upgrade whitewater park amenities
- Additional volunteer support for maintenance

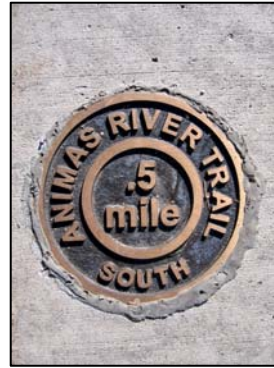
6.7.1 ANIMAS RIVER TRAIL (ART)

- Segments with asphalt surfaces are in need of patching and resurfacing in many areas
- Concrete surfaced segments are wider (10 feet) and more updated; asphalt surfaced segments are more narrow (eight feet) and in need of repair.

- Continue expansion of the ART both north and south of town
- Resurfacing and widening of older segments
- Additional interpretive and information signage

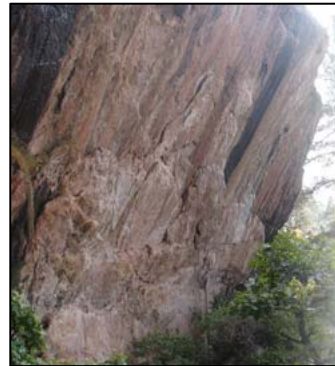
6.8.2 DALLA MOUNTAIN PARK

- Erosion and drainage control efforts are needed around road bed
- Parking is limited
- Limited sense of arrival at entry point
- Fire mitigation efforts are substantial

- Upgrade parking and trailhead area with improved interpretive amenities
- Maintain enforcement and regulation of “renegade” and social trail building
- Improved erosion and drainage control measures
- Way-finding signage

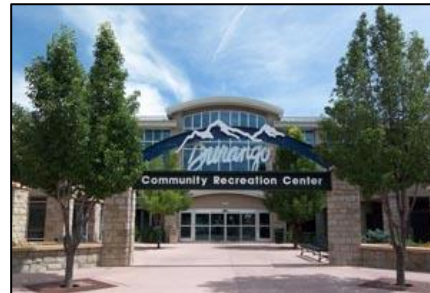
6.9.1 DURANGO COMMUNITY RECREATION CENTER

- Size of multiple amenities of the facility are under capacity of current demand and needs:
 - Fitness area – exercise equipment area has become cramped
 - Aerobics gym – too small to meet current demands
 - Family locker room – too small to meet current peak demands
 - Maintenance and storage areas – too small to meet current needs
 - HVAC unit of entry area
- Upgraded amenities would improve usage and customer experience:
 - Ventilation in aquatic area mechanical room is inadequate
 - Membership control point at reception desk can be improved
 - Remodel the youth area to include more technology components
 - Sprayscape maintenance presents substantial challenges
 - Spinning room is needed
 - Refreshed pool play equipment is needed
 - Utilities supporting the concession-operated café are not sufficient
